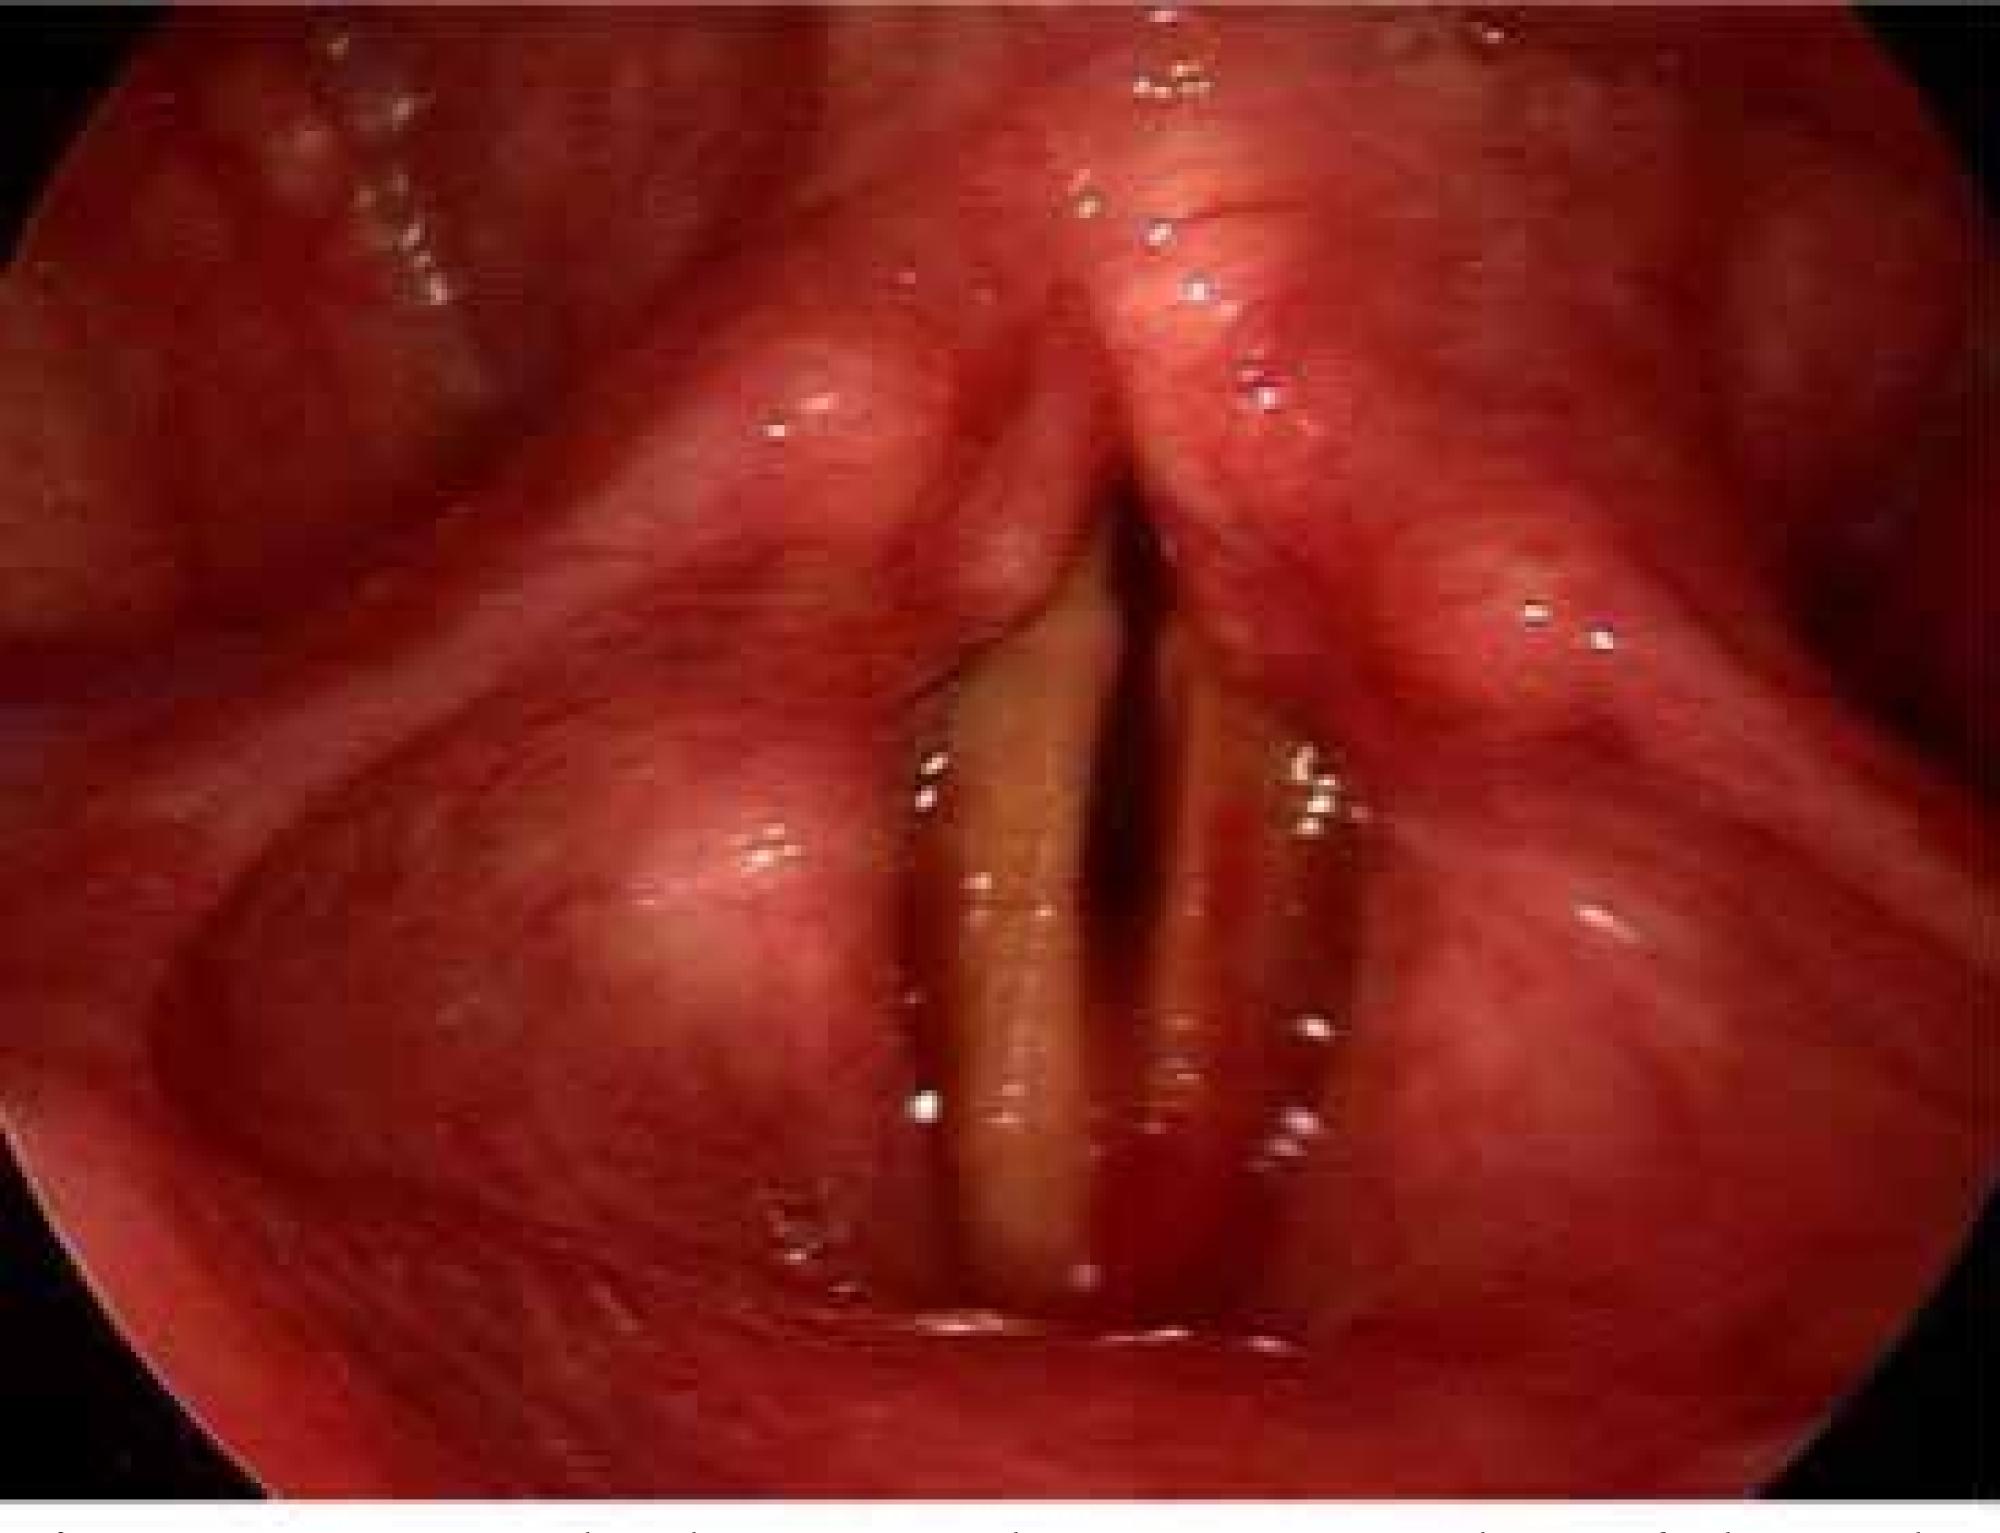
**Figure 7.** Post-operative day 1 laryngoscopy depicting an average degree of edema and ecchymoses following masculinization laryngoplasty.
